**2+1 roads
Sweden**

TRAFIKVERKET
SWEDISH TRANSPORT ADMINISTRATION

- How it all started
- Safety problem to solve
- Our 13m roads
- Safety result
- Maintenance

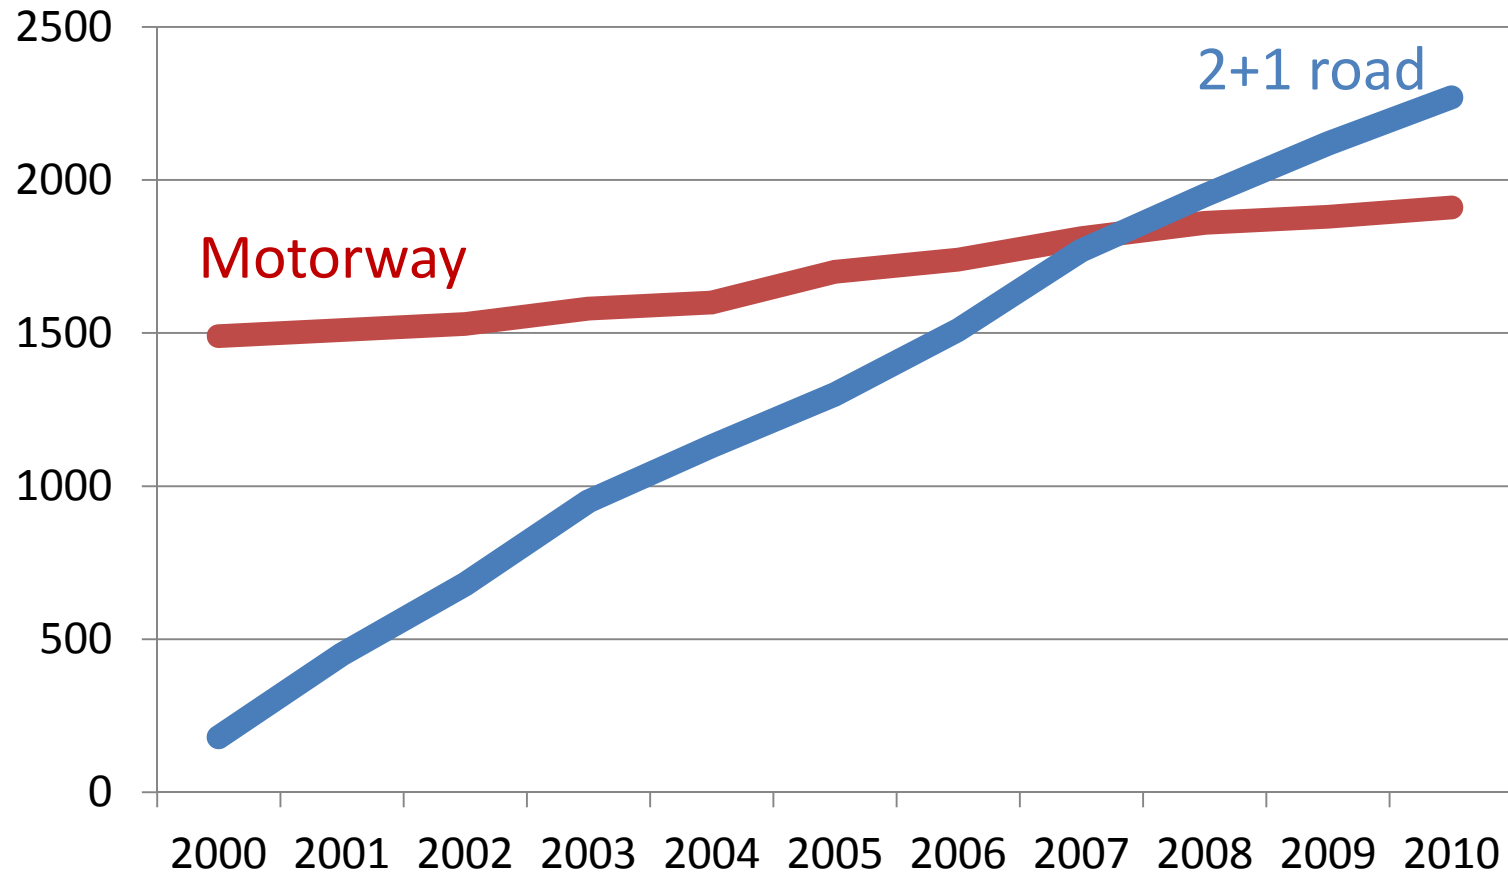
Size of the network

Mötesseparerad- och mitträfflad väg, antal mil

Length of roads in mil = 10km

2000	2001	2002	2003	2004	2005	2006	2007	2008	2009	2010
2+1-väg	18	45	68	95	113	130	151	177	195	212	227
Motorväg	149	151	153	158	160	170	174	181	186	188	191
Övrig mötesseparering.	21	21	22	22	23	24	24	25	20	20	23
Mötessep. total	188	217	243	275	296	324	349	383	401	420	441
Mitträffling	0	0	0	0	0	25	124	250	334	425	493

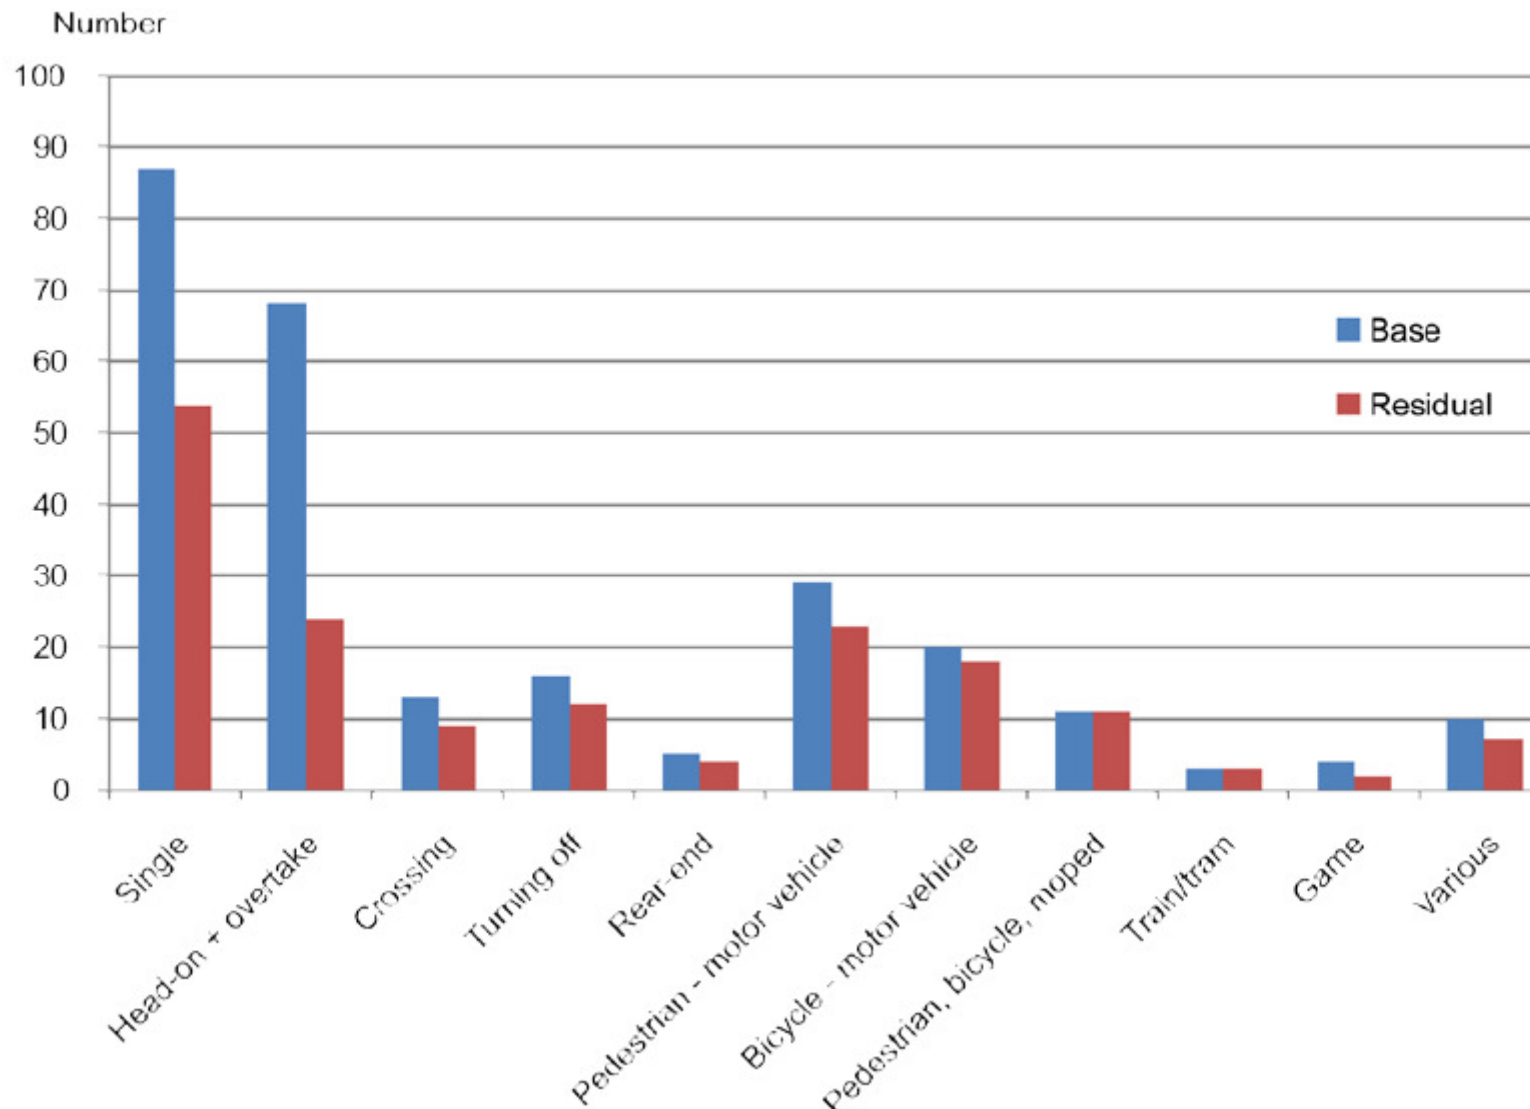
Figure 4.4. Prediction for fatalities in 2020 by type of accident based on projection of vehicle and infrastructure technology trends. Source: In-depth studies of fatal accidents.

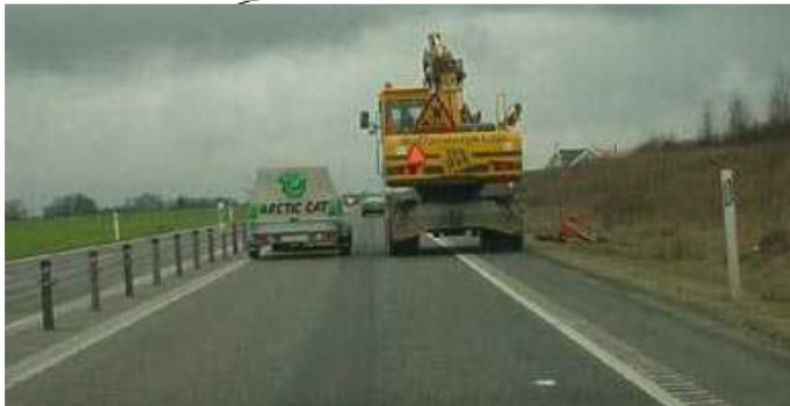
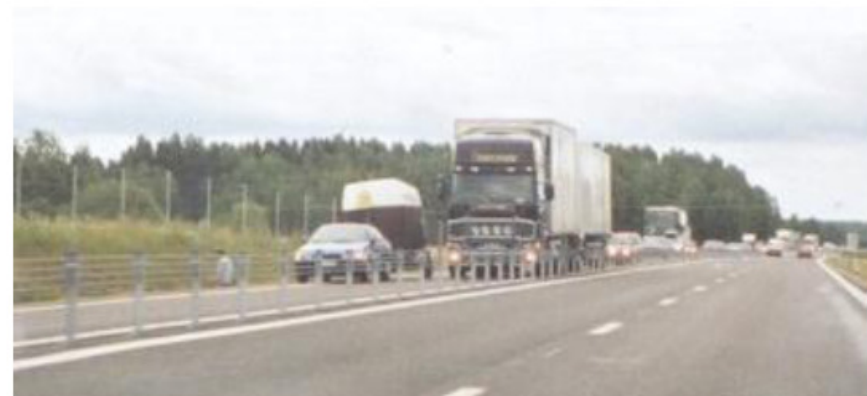
Barrier N2 W5 = 100/110/900/1500/20/1.7m

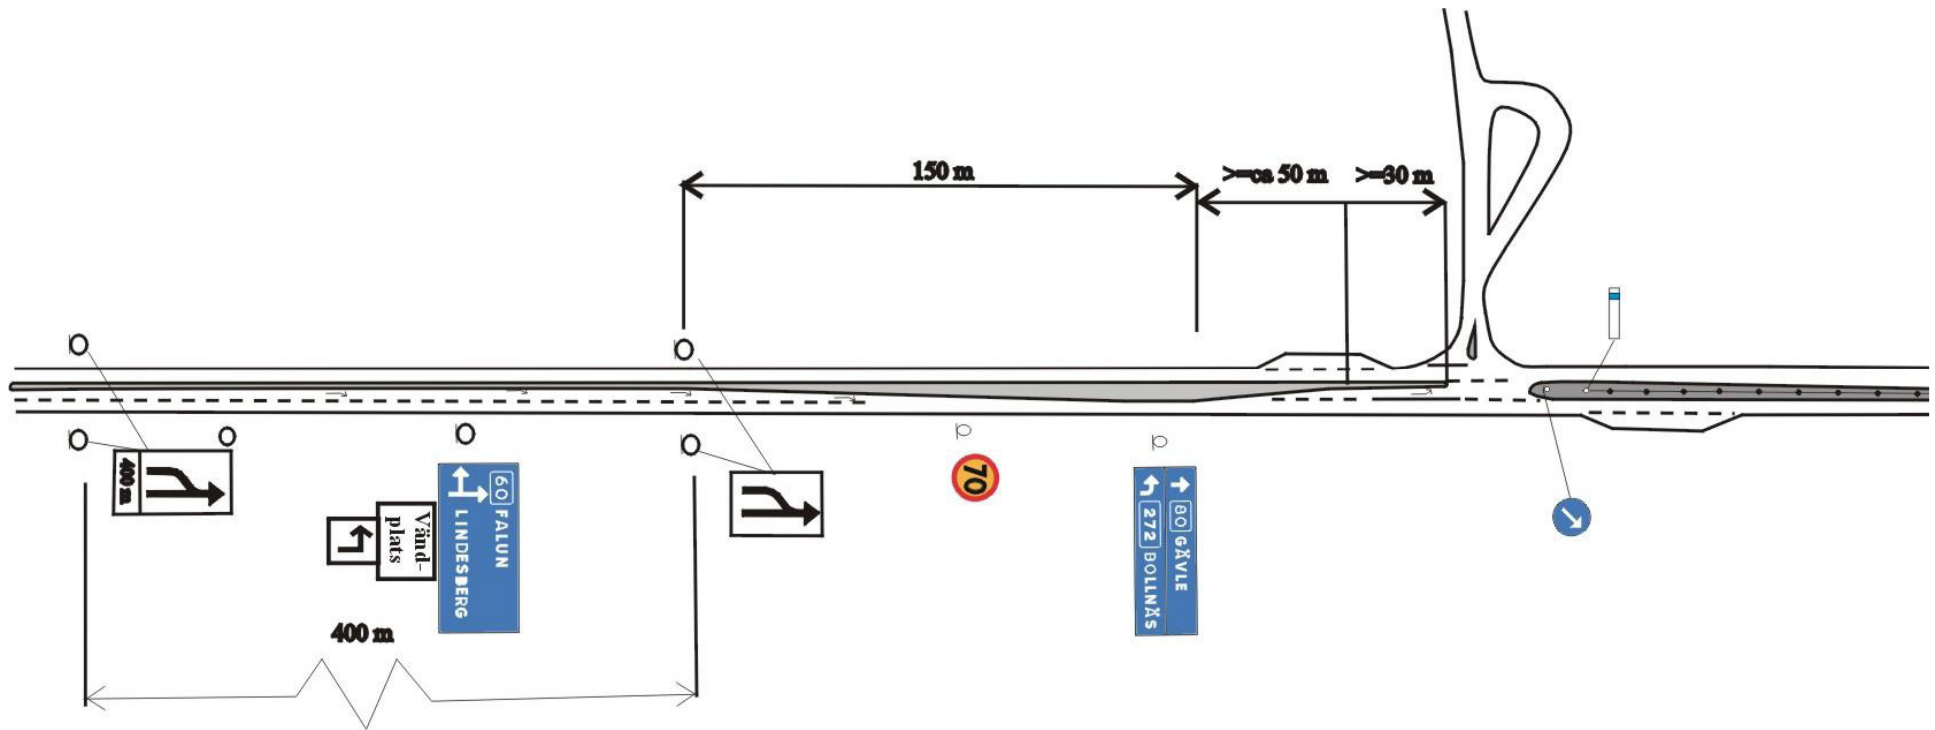
One lane in

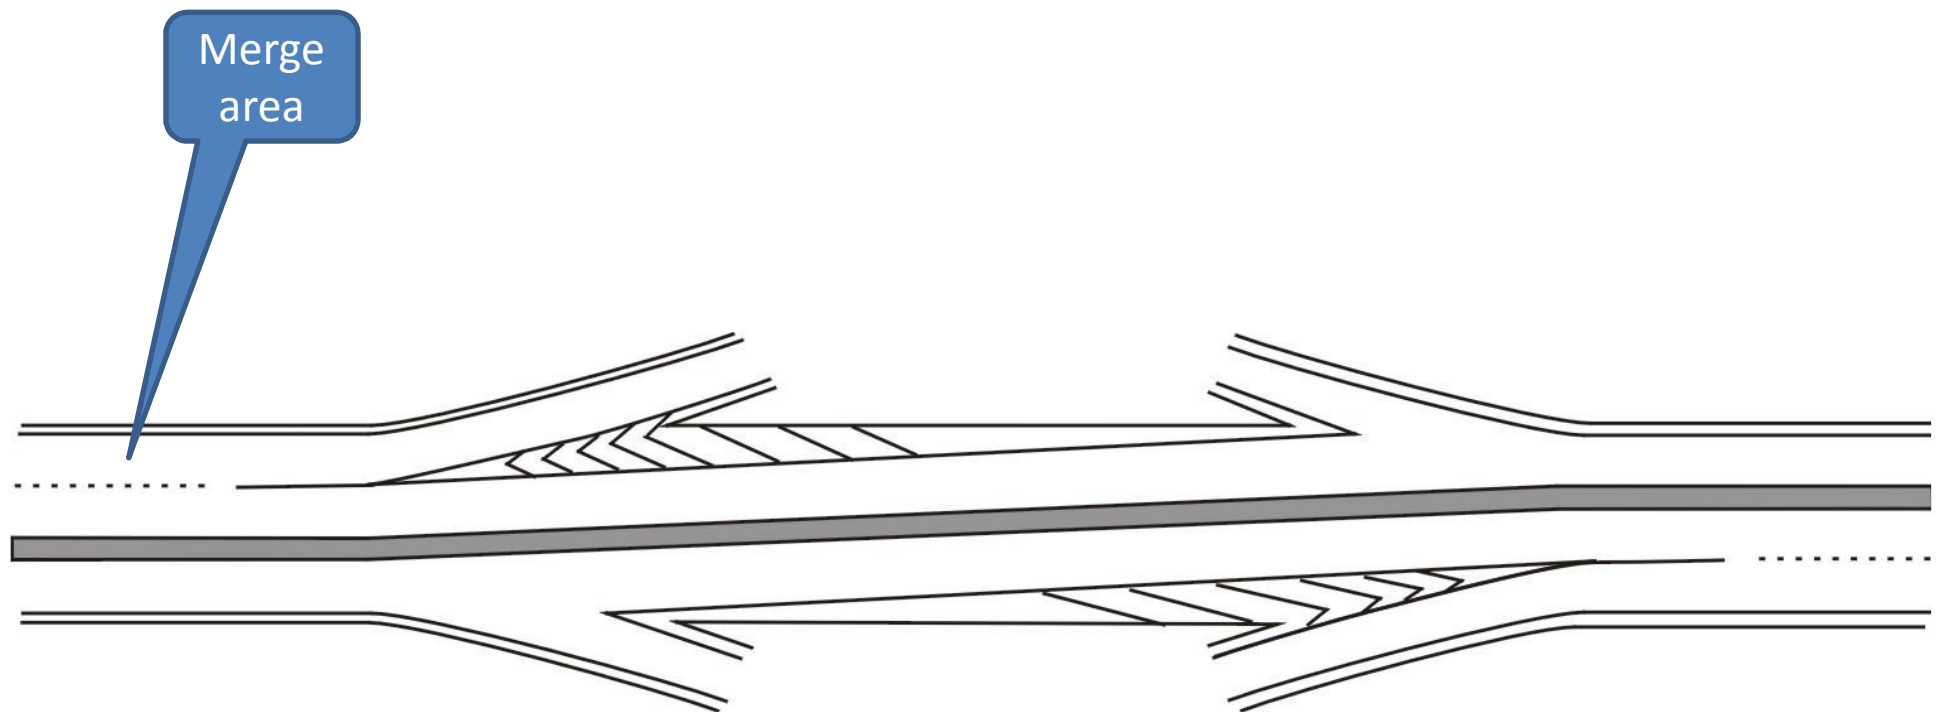
1 lane in and 2 lanes out

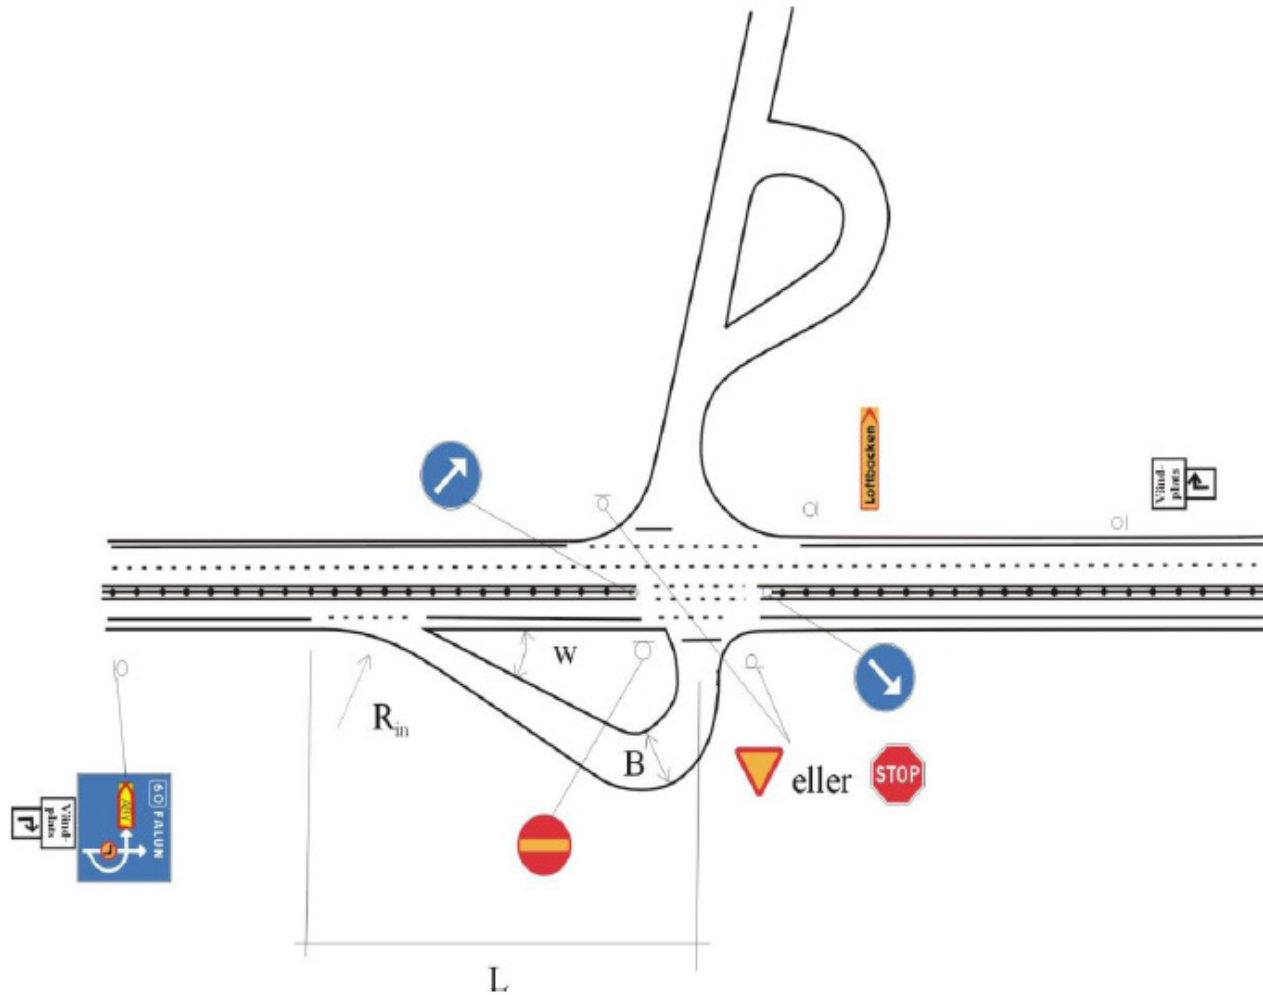
Right-turn access design

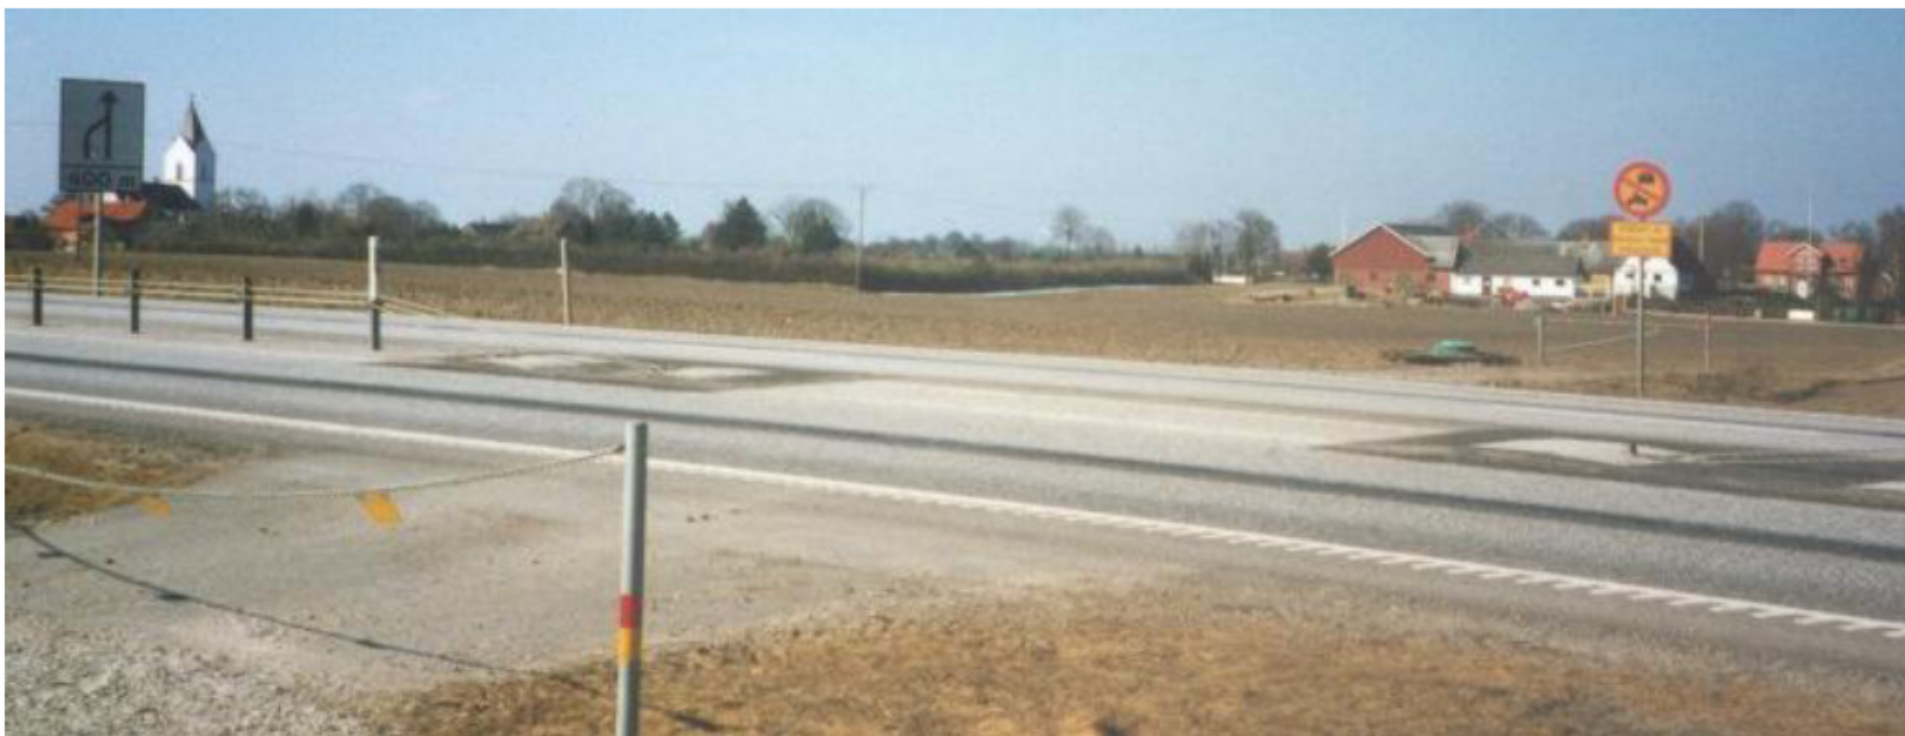
Farmer's crossing

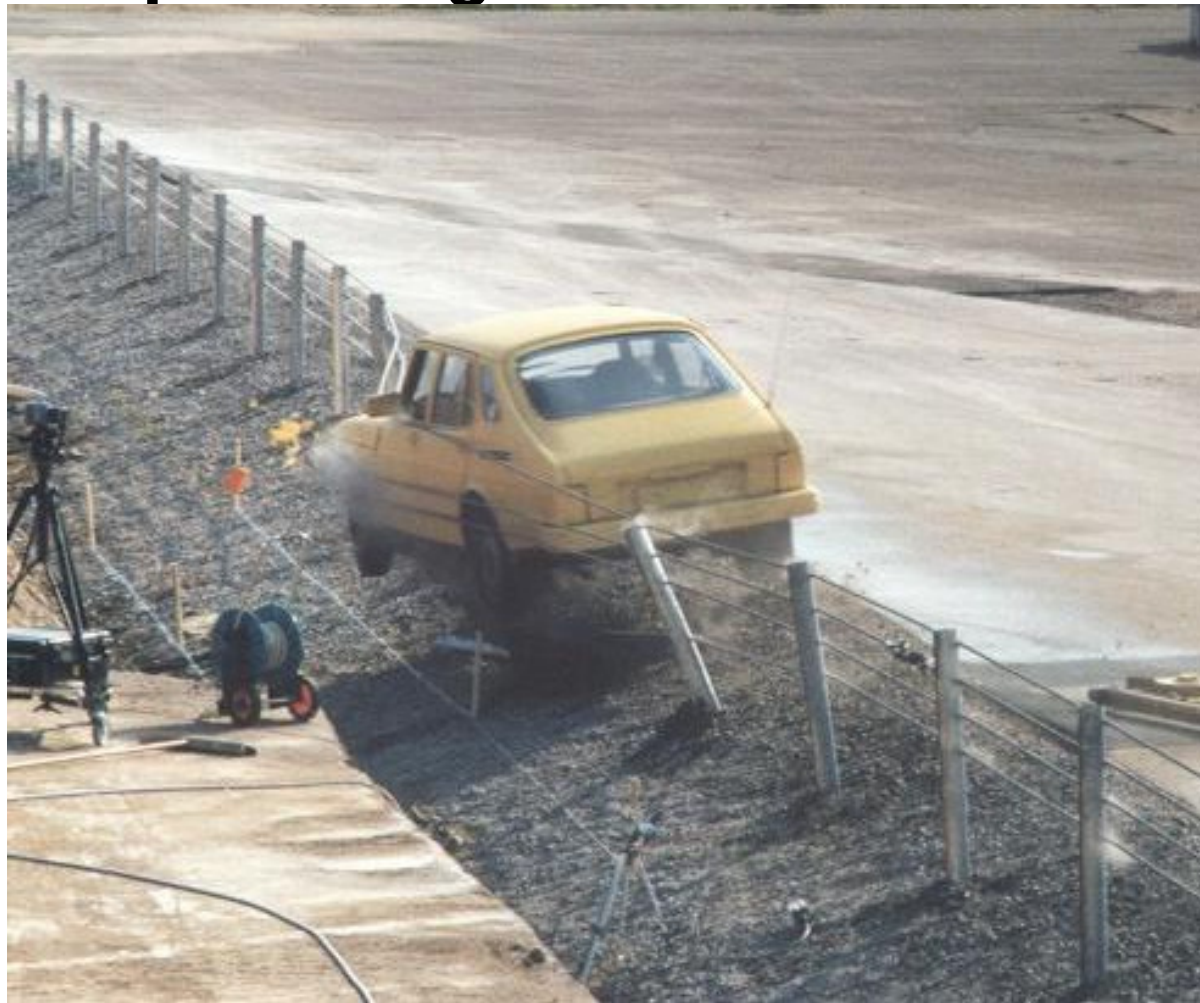
Approved for CEN N2 –900/1550 kg 120/110 kph 20 degrees

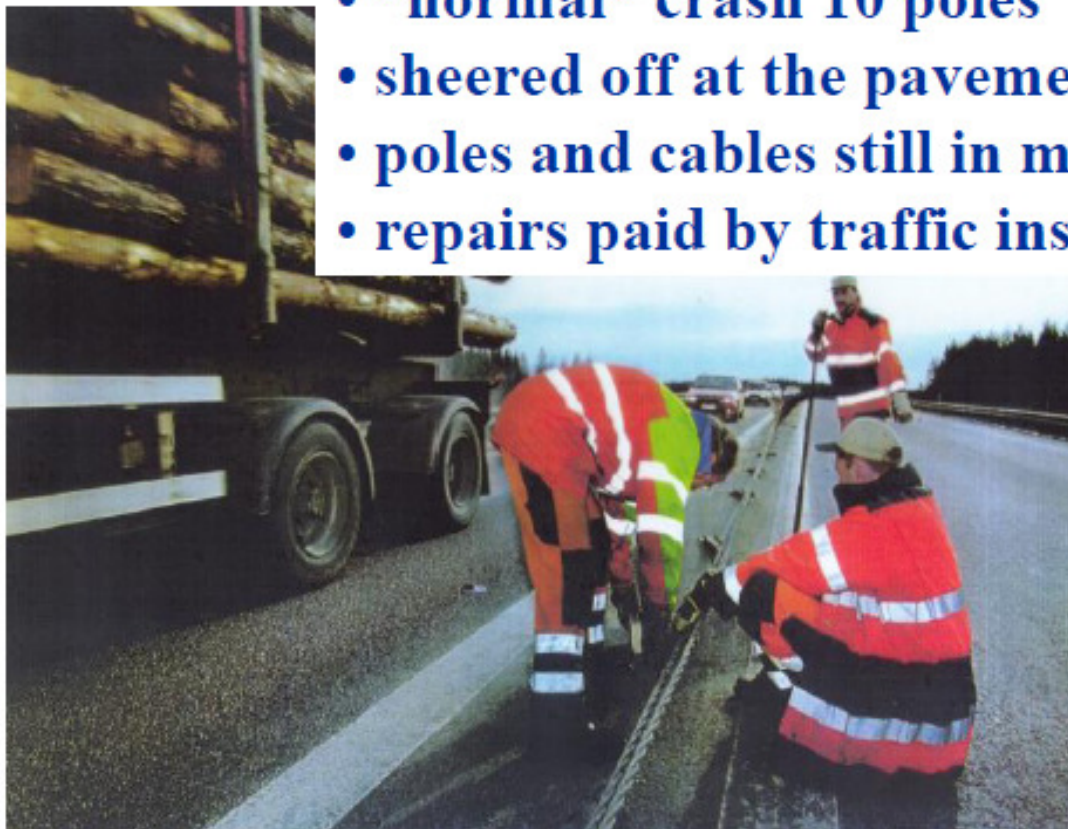
Barrier repair work zone treatment

- “normal” crash 10 poles
- sheered off at the pavement
- poles and cables still in median
- repairs paid by traffic insurances
